Rapid Repair of “SOGTHI” Dam Amidst Heavy Rainfall: Successfully Completed

SOGTHI DAM Rapid Repaired GUJARAT (INDIA)

IRRIGATION DEPARTMENT

DATE: 22/07/2024

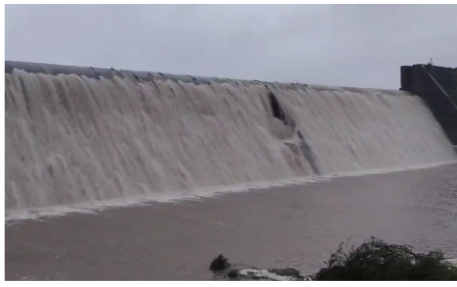
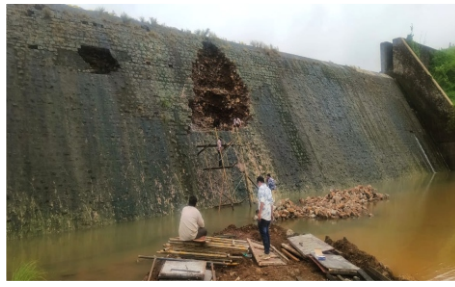
BEFORE

On July 20, 2024, the Sogthi Dam experienced significant damage on its backside due to heavy rainfall in the upper regions. The dam was overflowing, and continuous rain prevented any immediate repair efforts. The Gabdu, measuring 50 to 60 cubic meters, were compromised, causing internal jet leakage within the dam structure.
