Rapid Repair of “SOGTHI” Dam Amidst Heavy Rainfall: Successfully Completed

SOGTHI DAM Rapid Repaired GUJARAT (INDIA)

IRRIGATION DEPARTMENT

DATE: 22/07/2024

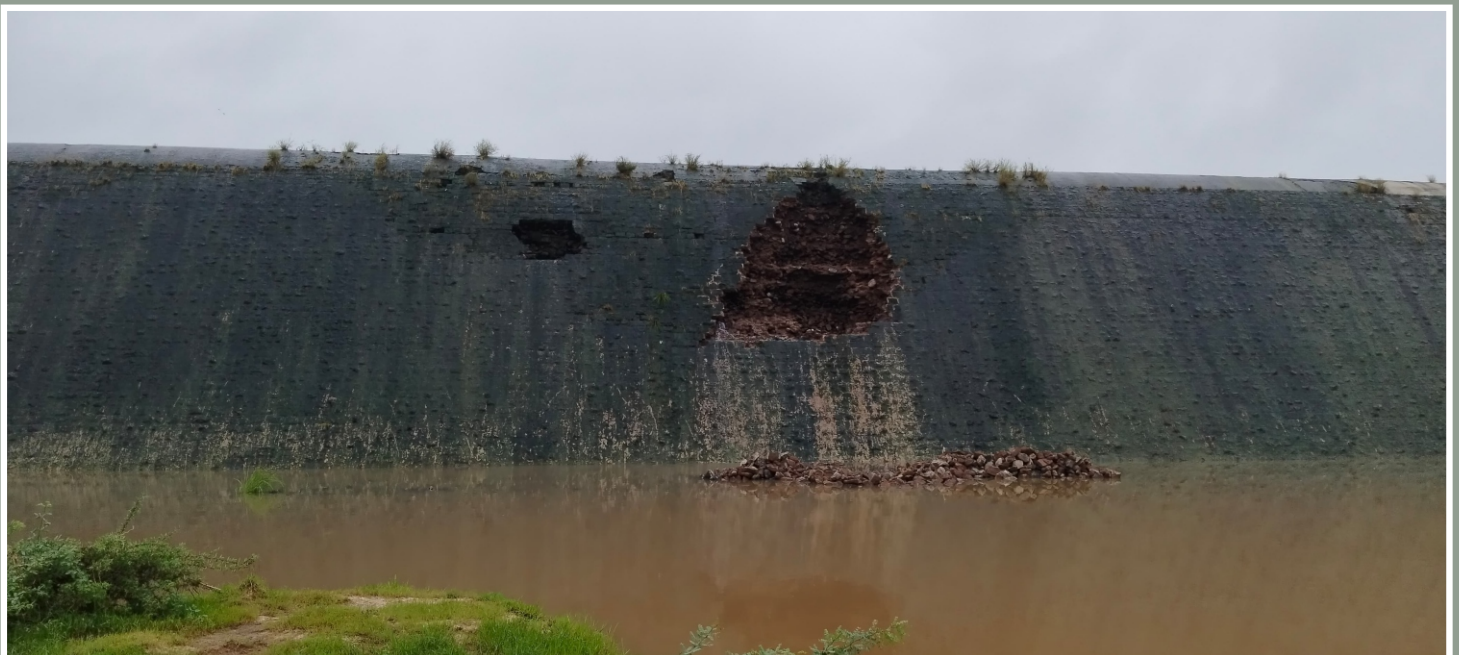
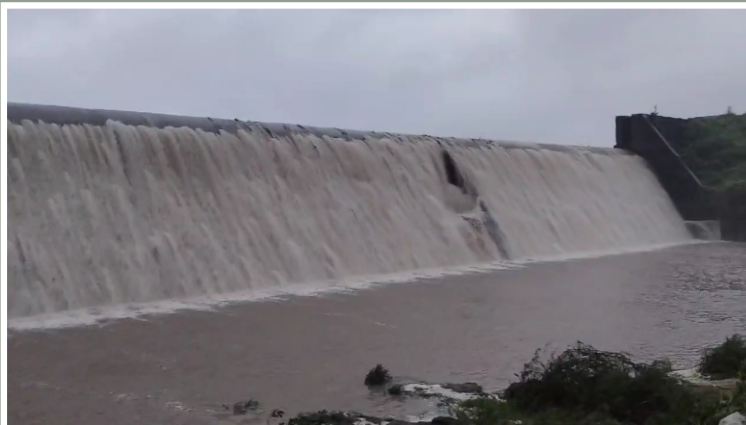
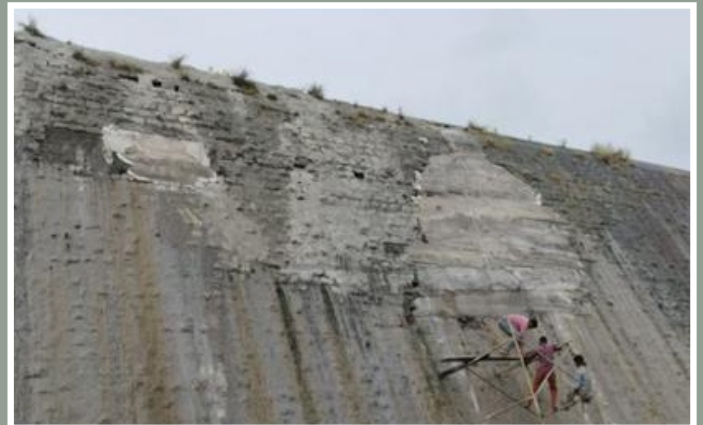
On July 20, 2024, the Sogthi Dam experienced significant damage on its backside due to heavy rainfall in the upper regions. The dam was overflowing, and continuous rain prevented any immediate repair efforts. The Gabdu, measuring 50 to 60 cubic meters, were compromised, causing internal jet leakage within the dam structure.

REDWOP accepted the challenge and commenced trials in our laboratories, achieving success. We informed the department that the repair could be accomplished using our admixtures: REDBRAWN 671 (0.8% of cement) for retention, Butabond SBR (2% of cement) for bonding old to new concrete, and REDWOP CA 94 (5% of cement) to accelerate concrete setting within 1 to 2 hours.

Approximately 55 cubic meters of concrete were utilized for the repair, which was completed within 36 hours.
